On the Boate Kiss Fire and the Brazilian Safety Legislation - What we can learn

Henrique Costa Braga · Gray Farias Moita

Abstract Brazil was recently the scenario of a great tragedy in the fire at Kiss nightclub, where 242 people were killed. The starting point of the fire was the use of a pyrotechnic device over an acoustic coating made of polyurethane foam. The casualties were caused mainly by asphyxia and inhalation of toxic gases in a very fast smoke expansion. However, several additional causes contributed to the amount of damage and human losses. The accident investigations emphasized the necessity to discuss details in the applicable Brazilian legislation. In this work, the tragedy of Kiss nightclub is presented and the some of their main aspects discussed. The Brazilian standard (ABNT NBR 9077) to determine the dimension of the emergency exits is also presented. It was found that, in spite of the configurations of Kiss nightclub have had a fundamental role in tragedy, the current Brazilian standard was not appropriate for the design of such an environment and should not have been used. Moreover, clear and more rigorous standards also need to be further discussed, particul

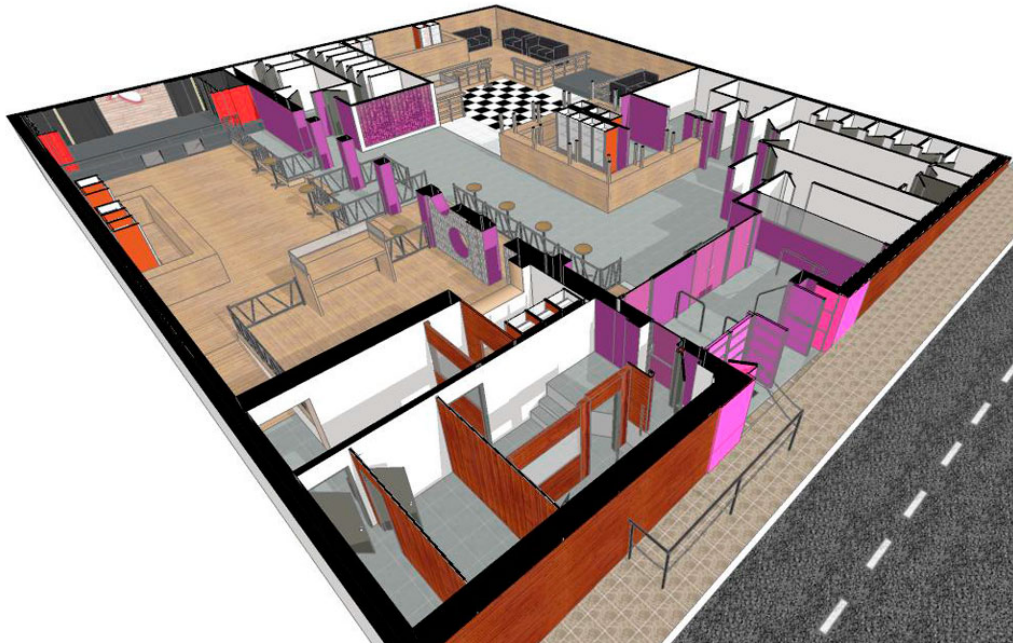
Kiss nightclub had only one floor and rectangular format, with dimensions 23.18 m in the main street by 26.45 m in length (in the design from 2009, the total indicated area was 615 m² [29]). Internally, Kiss nightclub had a sophisticated design, with various different sectors and some corridors, especially in the exit route (Fig. 1).

Figure 1 Schematic perspective view of Boate Kiss (image source: IGP-RS [16]).

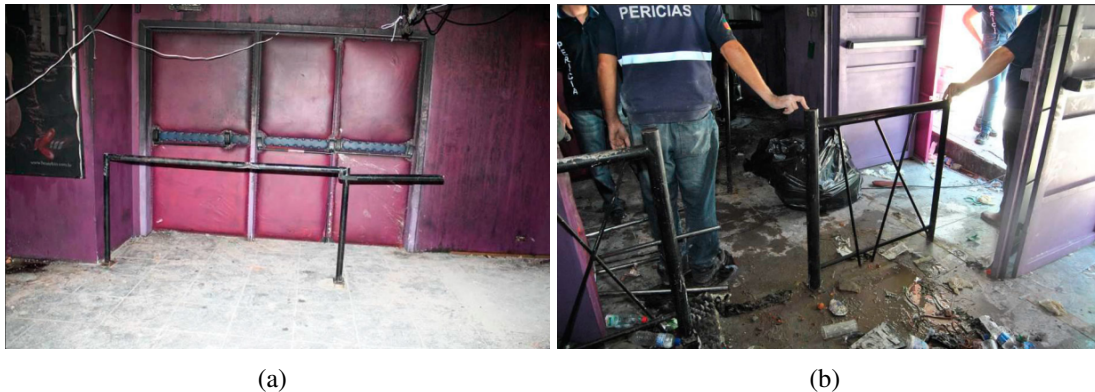
Additionally, instead of keeping the project from 2009 approved by the local municipality [29], and the environment according to what was previously approved by CBMRS in 2009 and 2011 [9], the owners have changed it. Some relevant modifications were made in the finishing materials (there is no acoustic foam in original plan) and also in the internal design (iron bars in the exit route were added (Fig. 3), amongst others).

Figure 3 Images of some of the bars added by owners in the evacuation route near to exit of Boate Kiss. Additionally, in (a) the middle door was locked (images source: IGP-RS [16]).

Fig. 5(d) shows again the intermediary doors from inside the nightclub, but without the bars showed in Fig. 3(a), because the bars - although firmly fastened to the floor - were torn by the crowd in despair, showing the degree of congestion caused by them (the bars

were put back afterwards by the investigators). Unfortunately the middle part of the triple door indicate in Fig. 5(d) (or Fig. 3(a)) was locked [16].

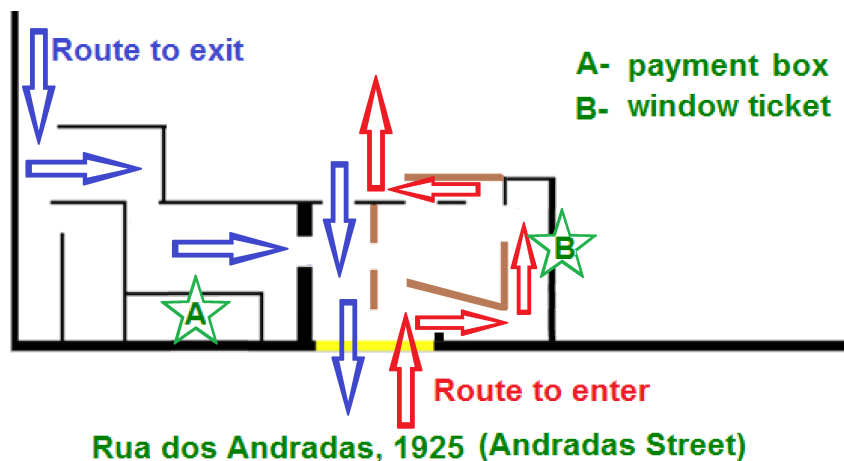
Figure 4 Stylized top view of Boate Kiss entrance area (in black the walls, in brown the bars showed in Fig. 3, in blue the route to the way out of the nightclub and in red the route to enter the nightclub, no scale).

terations in the original exit route occurred to facilitate the entrance and exit control, to avoid unauthorized people to leave the nightclub and to facilitate the bill payment (all the food and beverage consumption within the nightclub was paid only when the customer left the premises) and also allowed a more secure admission.

Fig. 4 helps us to understand these points, where the blue arrows show the path to be followed to exit the nightclub, and the red arrows show the path to be followed to enter the nightclub. The flow of people of this formal procedure for the control of entrance and exit resembles the operation of a “dropper”.
